U.S. Naval Hospital, Gate House (Bldg.23)
Park Boulevard, Balboa Park
San Diego
San Diego County
California

HABS No. CA-1548-T

HISTORIC AMERICAN BUILDINGS SURVEY
ARCHITECTURAL DATA FORM

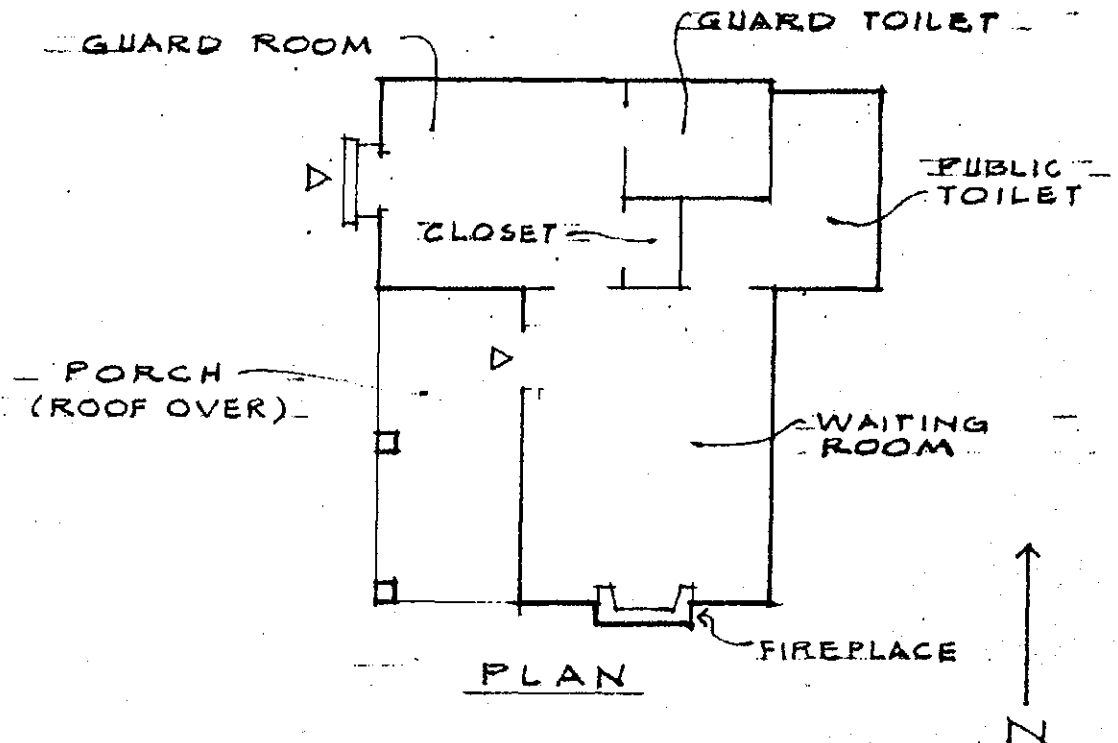
GATE HOUSE (BLDG 23) HABS No. CA-1548-T

ORIGINAL FLOOR PLANS
